## GOOD CONSERVATION AND RESTAURATION PRACTICE FICHE

Composed by working party of: Docomomo Serbia

### 0. Name of building/ group of buildings/ urban scheme/ landscape/ garden & picture of before and after

Depicted item: The Banovina (The administrative building of the Autonomous Province of Vojvodina)

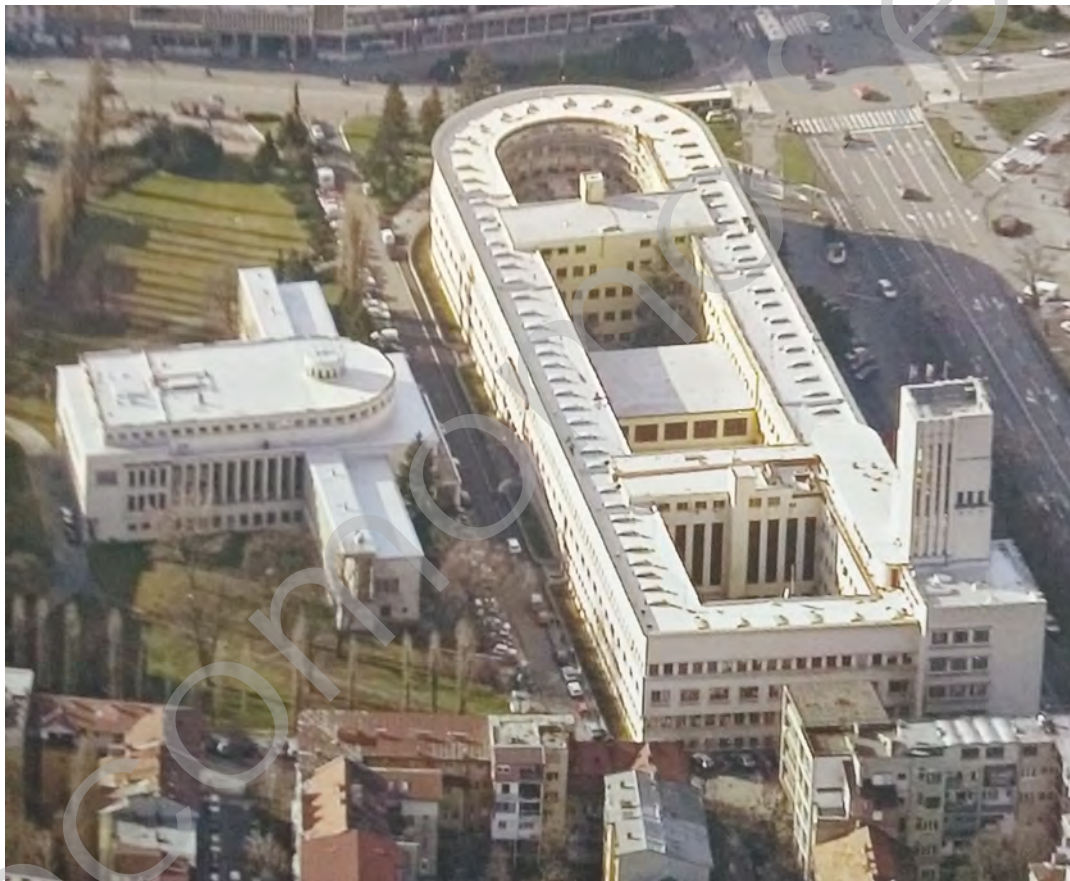
Before conservation/ restauration

For more than 80 years the facades of the building have not been cleaned. There were minor and, unfortunately, occasional bad interventions such as removal of graffiti using the grinders which damaged the surface of the stone, and some minor sealings with cement. Over time, due to atmospheric water, air pollution (the facility is located on a very busy road Bulevar Mihajla Pupina), formed changes on the stone facades from slight contamination - in the color, through sulfation with and without black crusts, the presence of facade paint, graffiti, and on the north side lichens and mosses.

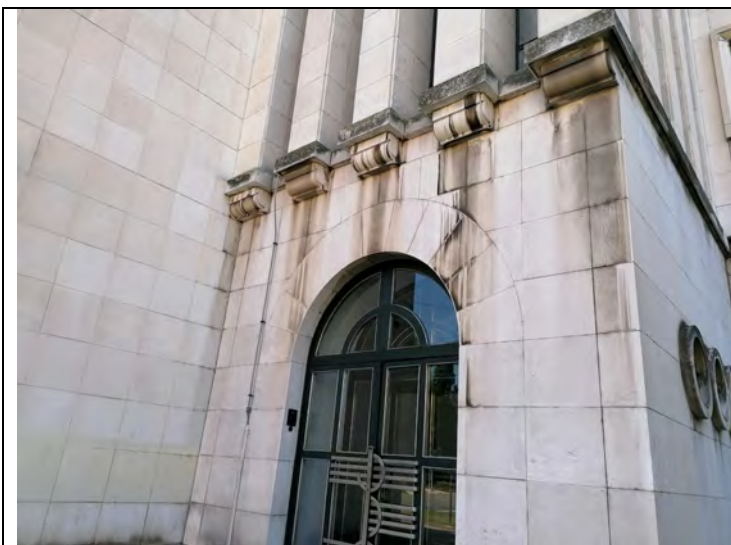
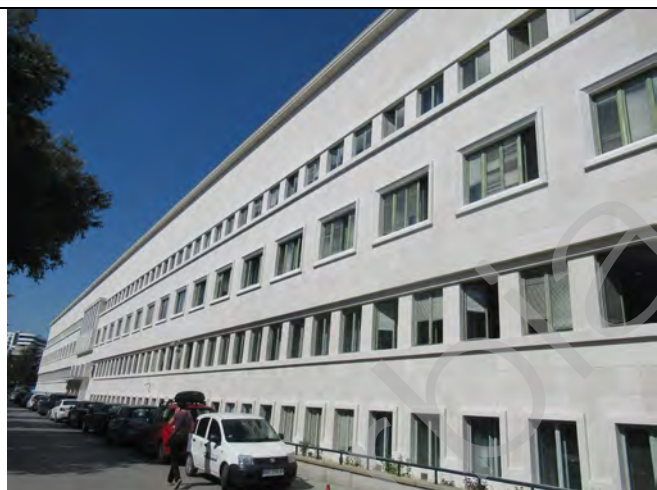
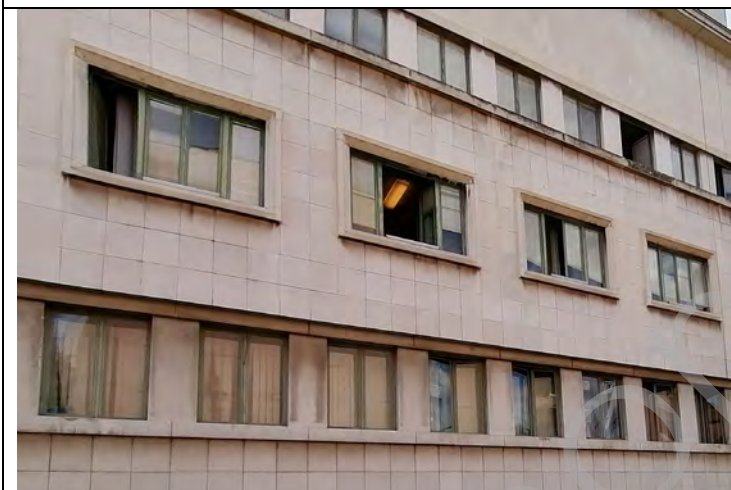
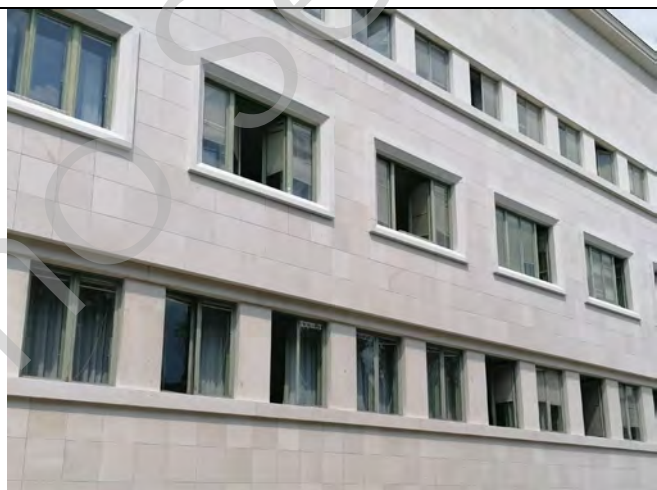
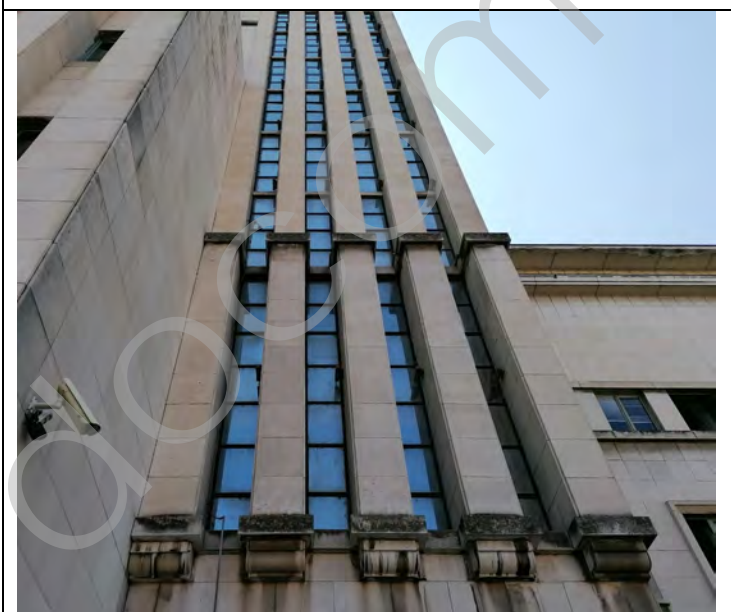
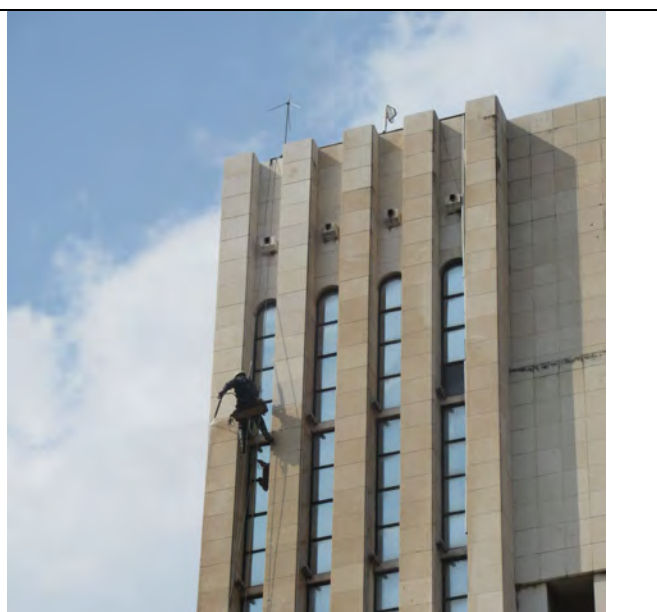
After conservation/ restauration

effect of changes: The total area of the cleaned facade is 10,600 m<sup>2</sup>, and the length of the repaired joints is about 1500m<sup>1</sup>.

Cleaning the facade was the most demanding task. It was necessary to remove various types of contaminants (sulfates, chlorides, nitrates, alkyds, acrylates, etc.) without destroying the patina formed on the surface of the stone and which protects it from the penetration of algae and bacteria into the interior of the structure. The study as well as the Project predicted that the largest part of the facade should be cleaned with a steam cleaner, alkalized water vapor with a pH of about 8, a water vapor temperature of 1480 C and a pressure of about 4.5 bar. On the horizontal prominent parts (window sills, window frames and bank) where there were black contaminants, and especially on the north side of the facade facing the heavy traffic of the Bulevar Mihajla Pupina,

During the cleaning, it turned out that in some places these planned funds were not efficient enough, so the others were added, which were first tested on a smaller area by a mobile laboratory of the Faculty of Technology and only then approved for further use. On some surfaces, it was necessary to physically remove parts of previous inadequate repairs, patch cracks and then seal these as well as other crater damage observed on the facade and then consolidate with the prescribed means of the manufacturer Remers, Germany. The inspection established that the existing joints between the stone slabs were in very good condition and only partially had to be cleaned and refilled with Ceresit CE mass, which was tinted according to the tone of the existing joints.

Parts of the façade that were more clogged and thus cleaned in more detail, as well as the entire ground floor area of the building, were coated with Funcosil FC, which performs additional hydrophobization and at the same time has an anti-graphite function.
